Re: Notice of Violation
RCRA Compliance Evaluation Inspection – Fermi National Accelerator Laboratory
EPA ID No.: IL6 890 030 046

On April 20, 2016 a representative of the U.S. Environmental Protection Agency inspected the United States Department of Energy Fermi National Accelerator Laboratory (Fermilab) facility, located in Batavia, Illinois. The purpose of the inspection was to evaluate Fermilab's compliance with its hazardous waste storage permit and certain provisions of the Resource Conservation and Recovery Act (RCRA); 42 U.S.C. § 6901 *et seq.* (RCRA); specifically, those regulations related to the generation, treatment and storage of hazardous waste. A copy of the inspection report is enclosed for your reference.

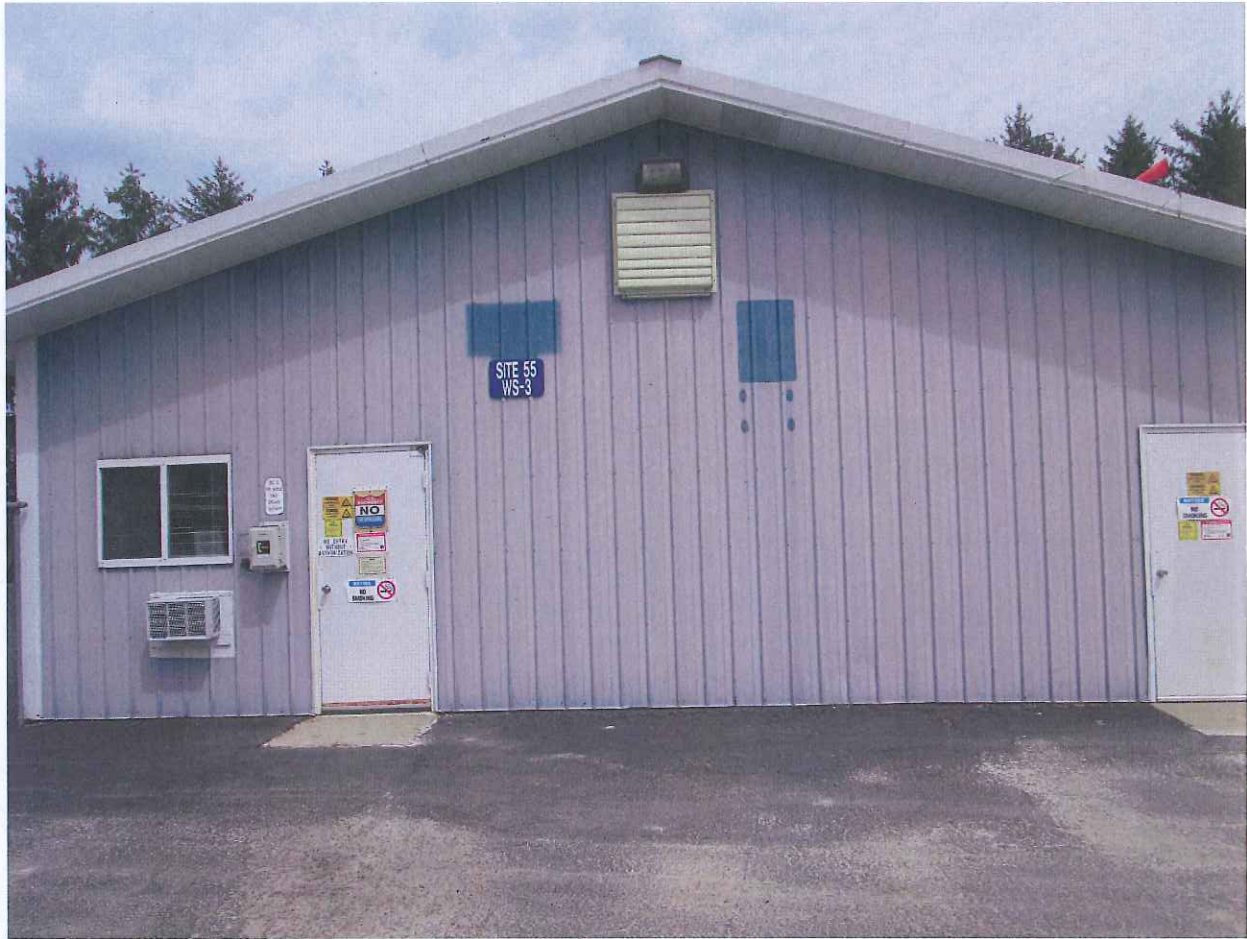
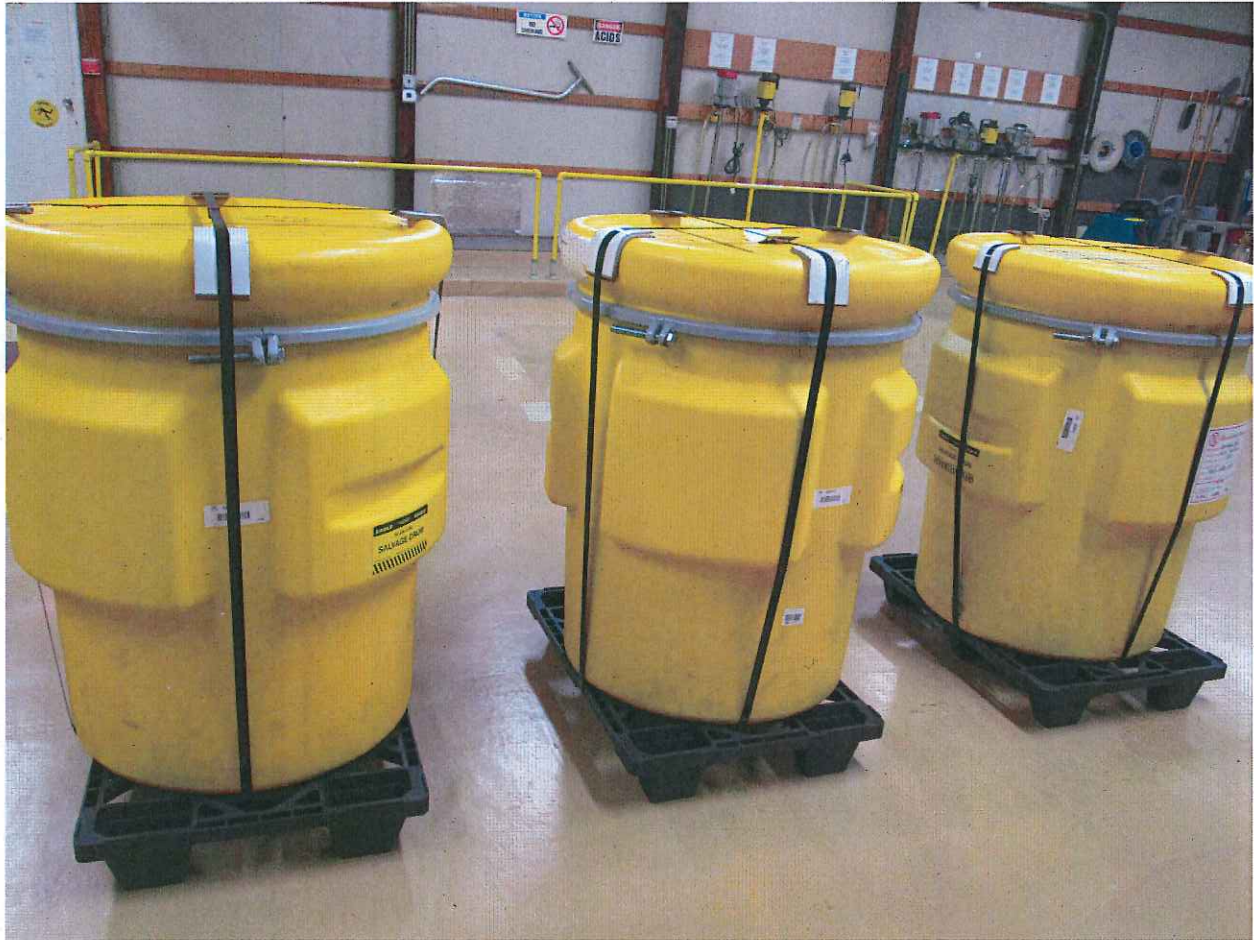
PHOTOGRAPH: 1

The tour began in building WS-3, permitted storage building where hazardous waste may be stored up to one year. I observed three 30-gallon containers of electrolyte etch (D002) stored in 65-gallon over packed containers (Photographs 1 and 2). I also observed one, 55-gallon container of PCB waste and one flammable storage cabinet with mercury containing equipment

SCENE BEING PHOTOGRAPHED: permitted hazardous waste storage unit

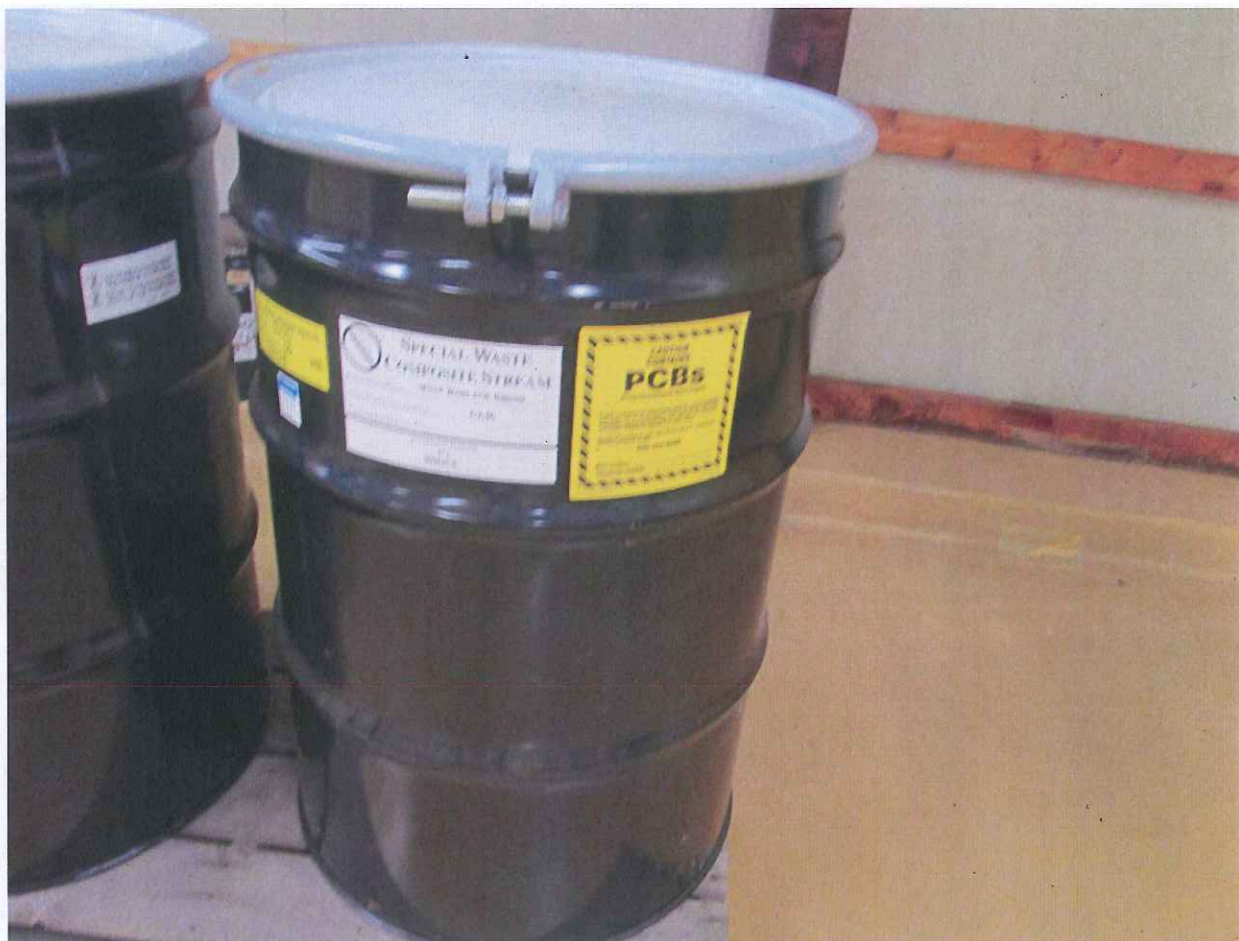
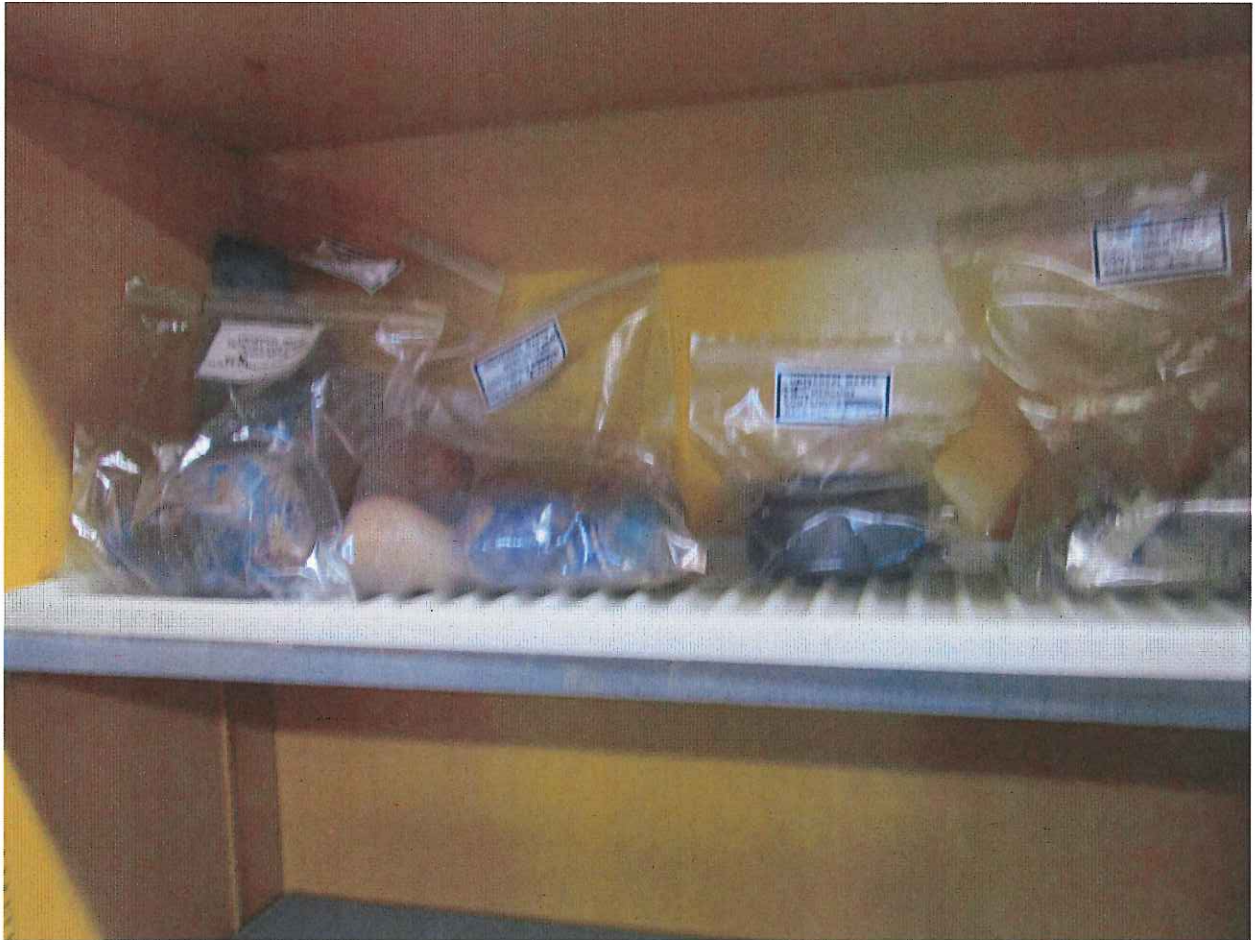
PHOTOGRAPH: 3

and thermometers (Photographs 3 and 4). There was also an empty mixed waste storage cabinet. All containers and cabinets were closed and labeled. The entire floor of WS-3 is constructed of reinforced concrete, epoxy-coated and free of cracks. It is also equipped with a four-inch berm.

PHOTOGRAPH: 4
NAME OF PHOTOGRAPHER: Sheila Burrus
DATE OF PHOTOGRAPH: April 20, 2016
LOCATION OF PHOTOGRAPH: Site 55, WS-3
SCENE BEING PHOTOGRAPHED: thermometer and mercury containing equipment
SITE LOCATION: 1375 N. Meacham Road
Schaumburg, IL 60173
Fermilab
INSTALLATION NAME:
INSTALLATION I.D. # ILR000056689

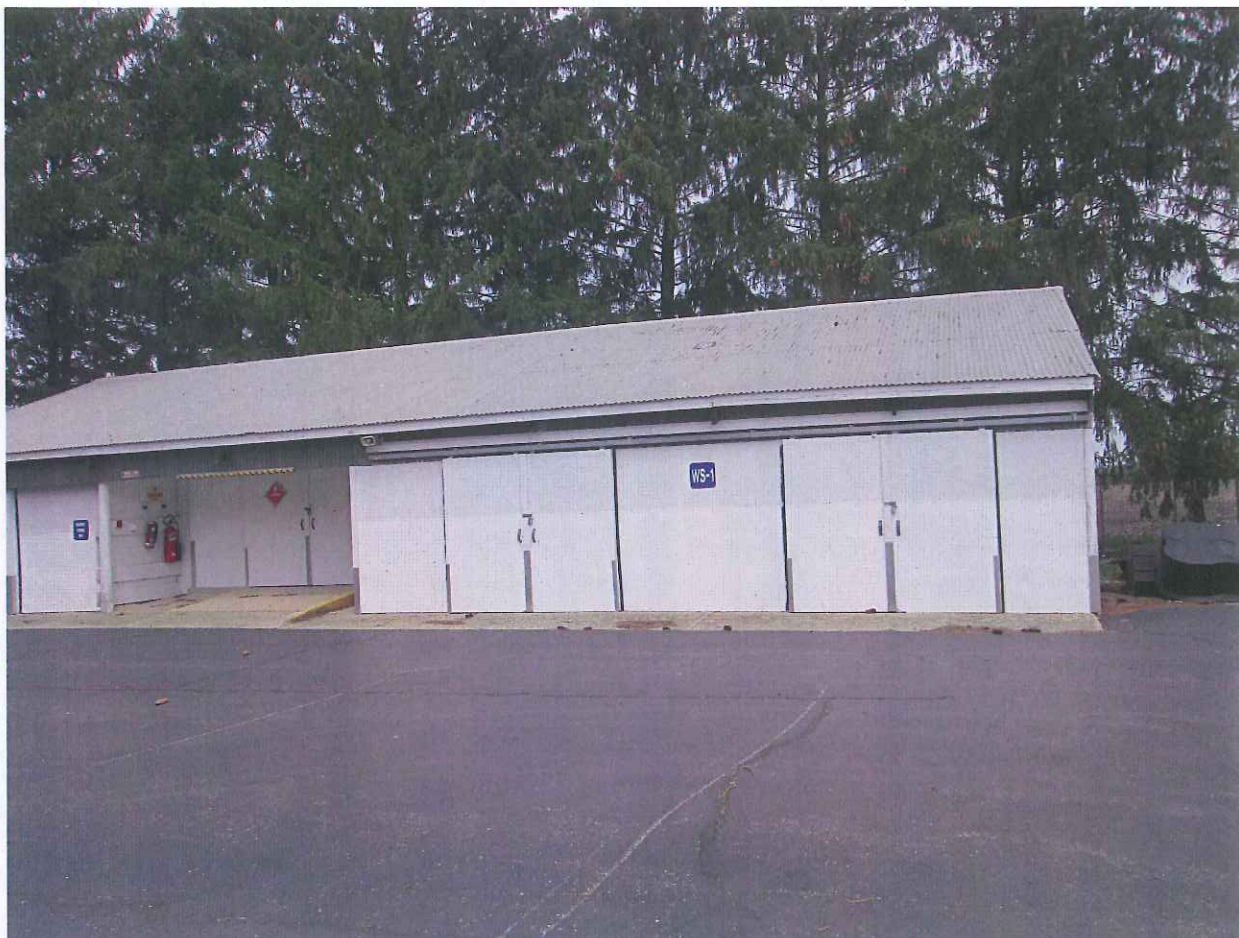
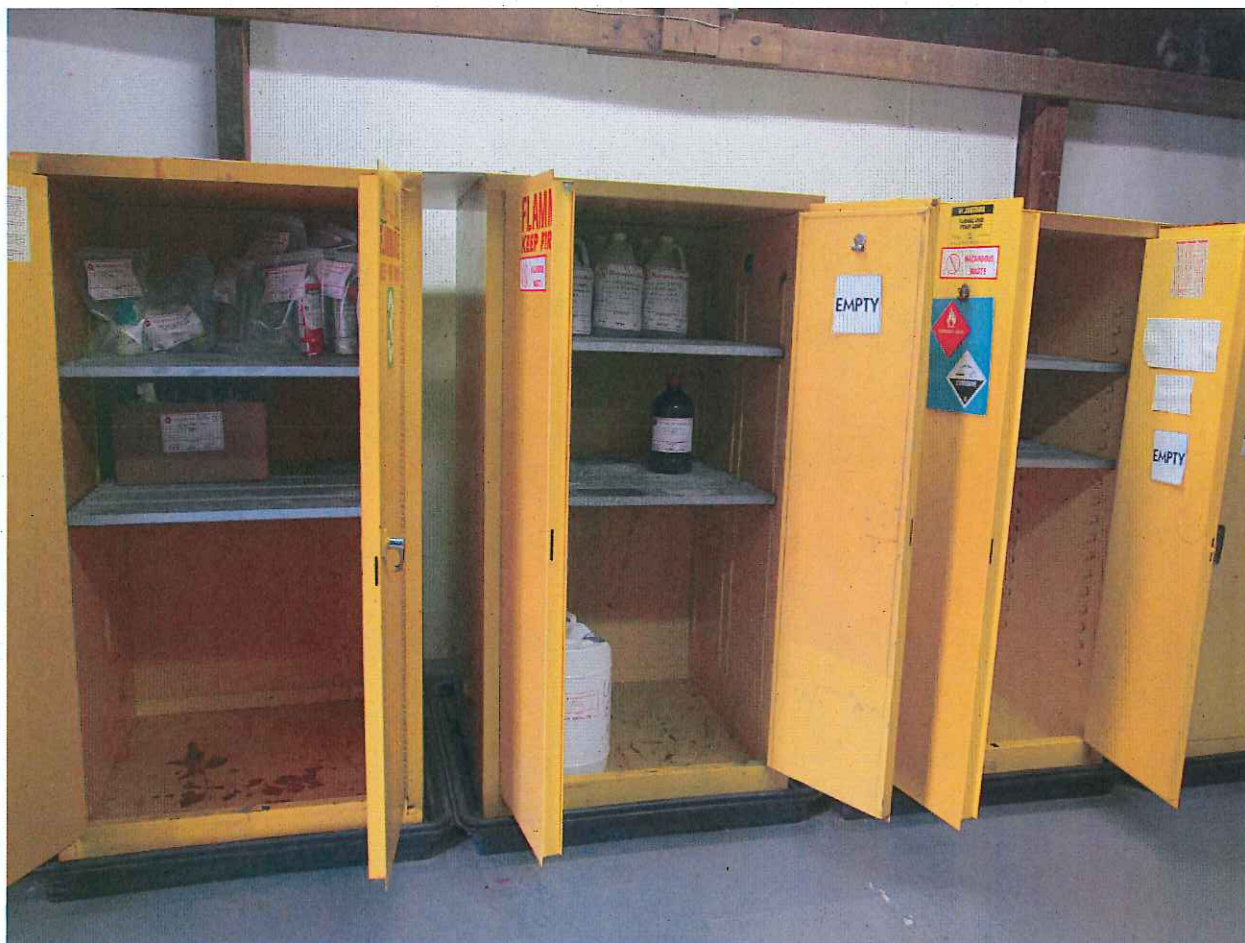
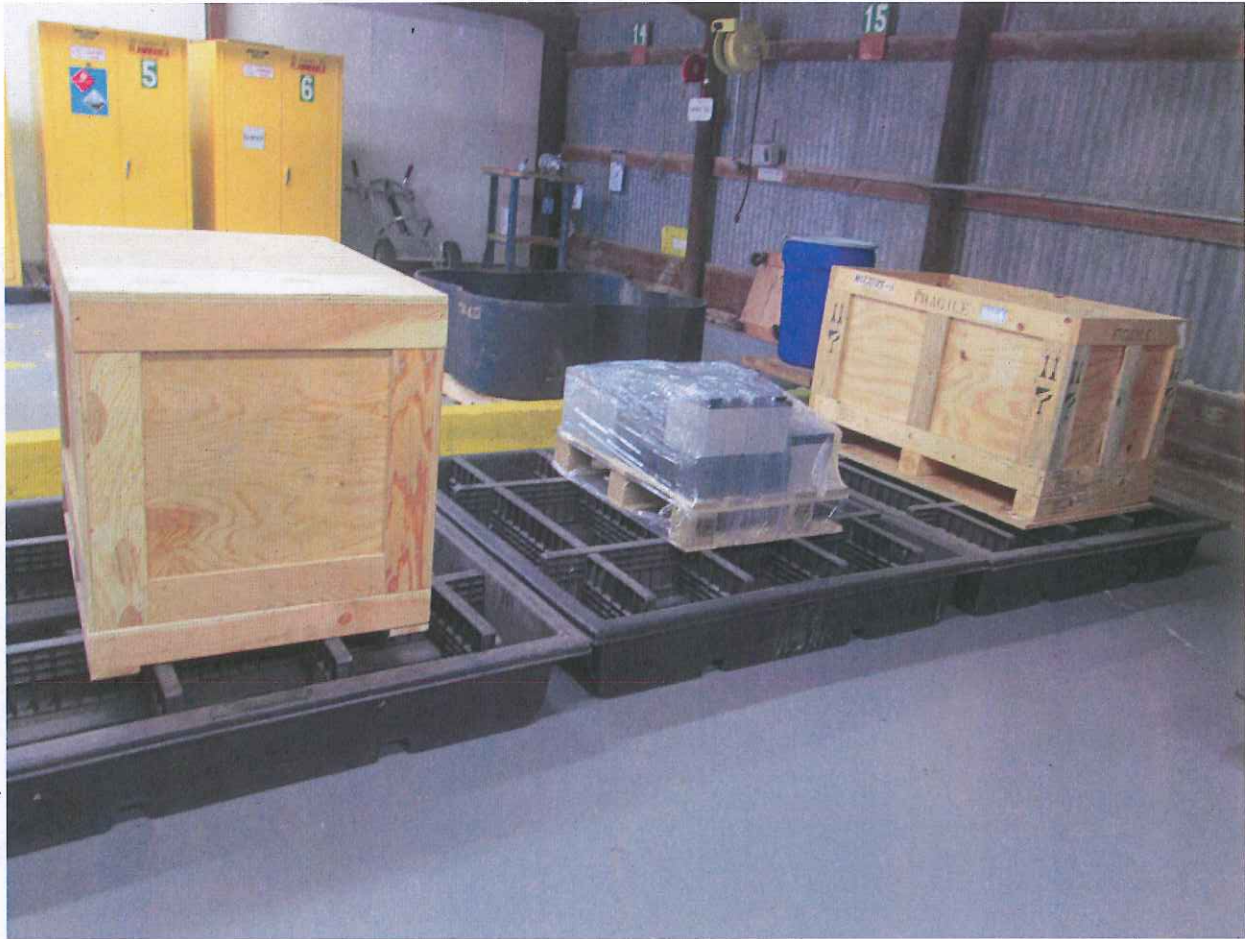
PHOTOGRAPH: 5

We proceeded to building WS-1, where I observed four flammable storage cabinets. Three of the cabinets were storing aerosol cans, used ethanol and piperidine. The fourth cabinet was empty at time of inspection. I also observed two containers and one pallet of lead batteries (Photographs 5 through 7).

SCENE BEING PHOTOGRAPHED: 90-day hazardous waste storage building

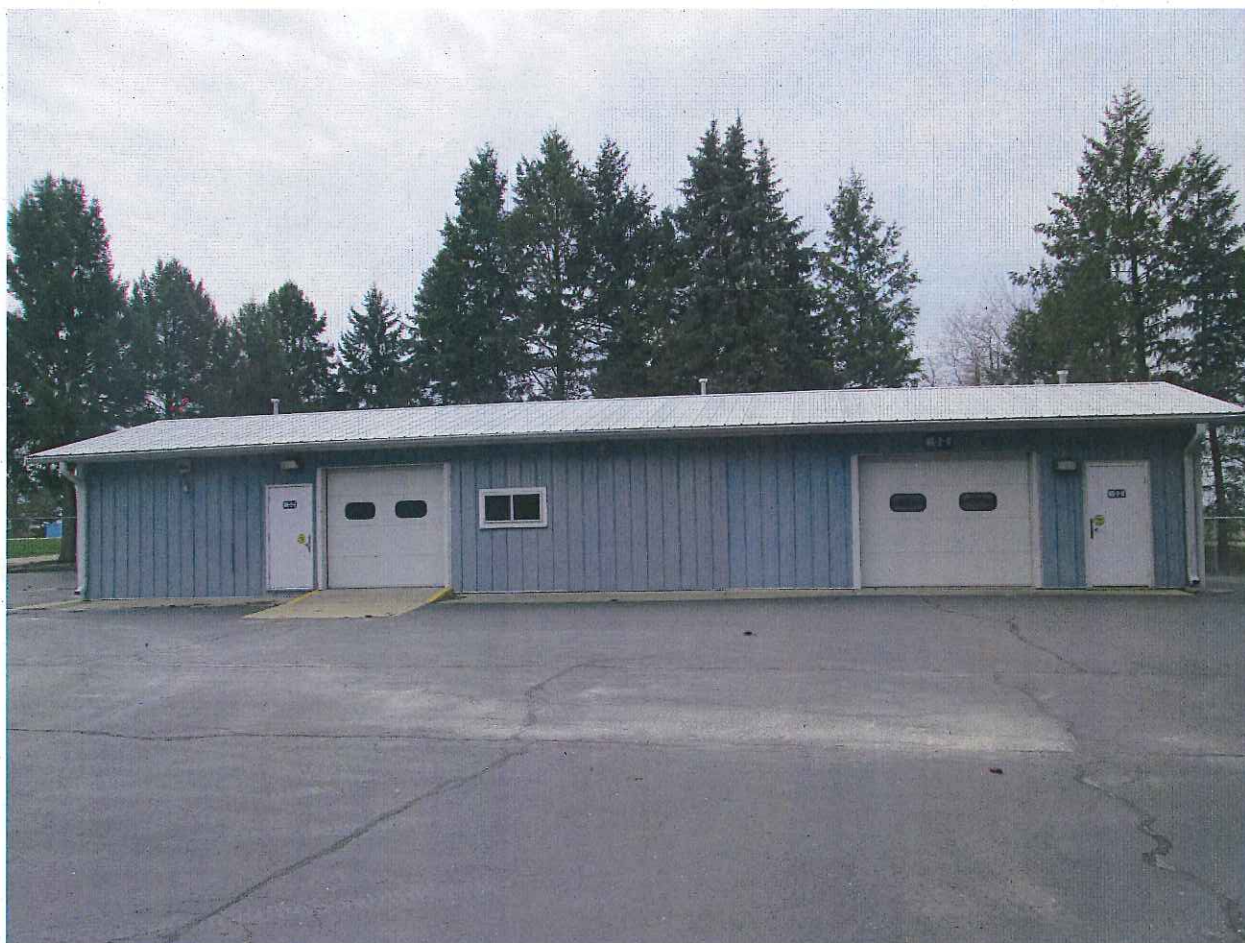
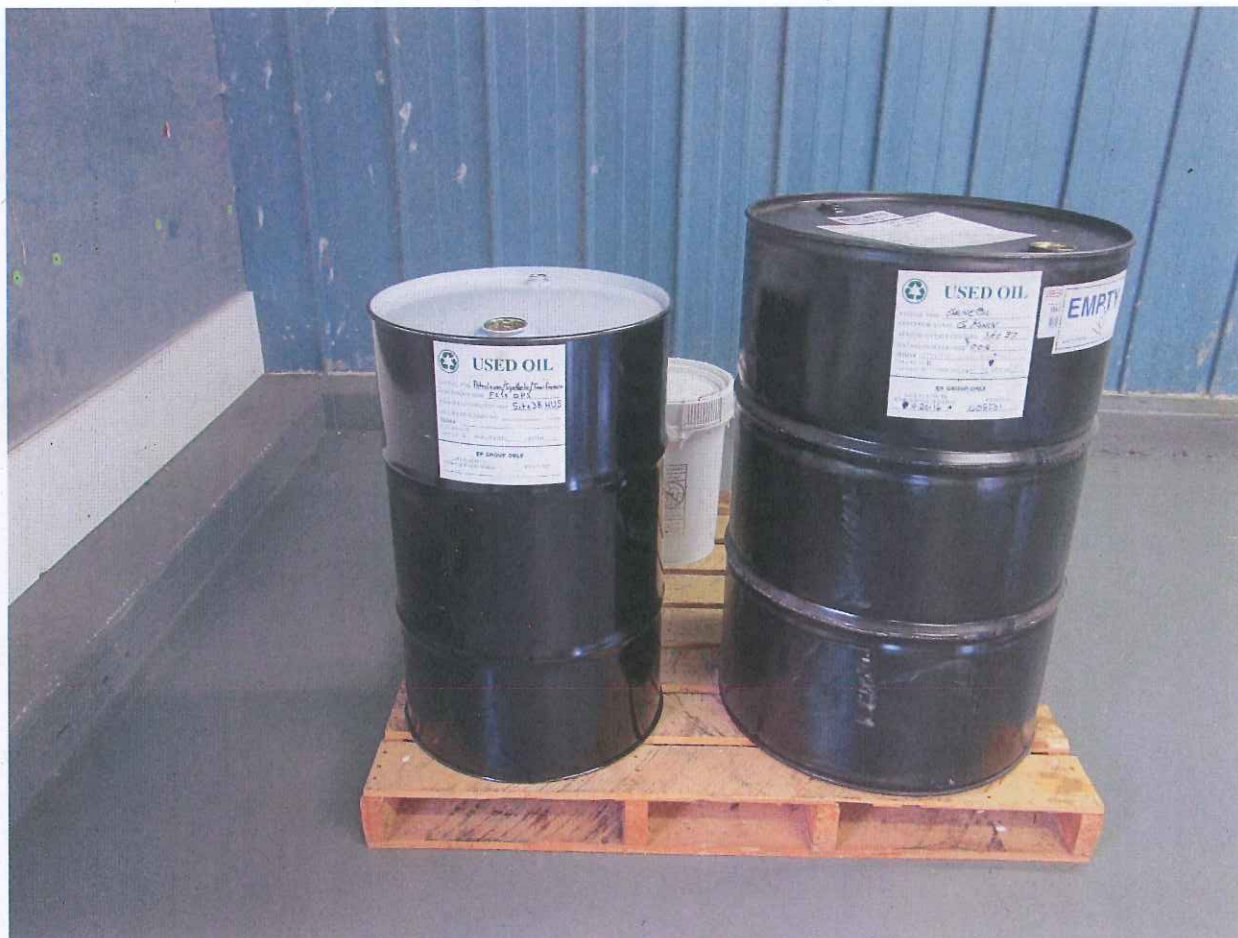
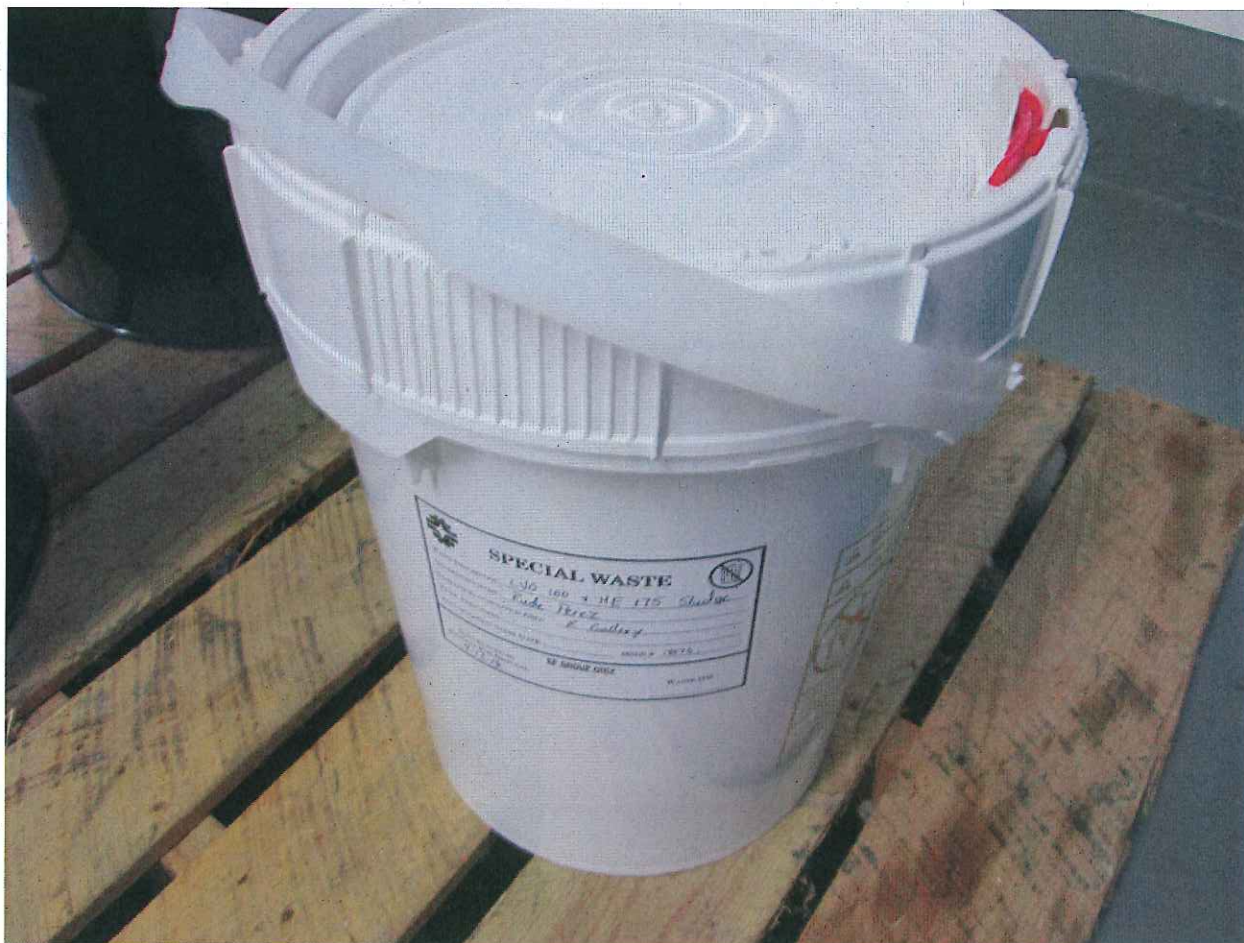
PHOTOGRAPH: 8

Next, we proceeded to WS-2 (East) where I observed one 30-gallon/one 55-gallon container of used oil and one 5-gallon container of special (oily sludge) waste (Photographs 8 through 10). There were also two 55-gallon containers of lead paint, four 55-gallon containers of coolant/oily diesel fluid and one 30-gallon container of oily rags (Photographs 11 through 14). All containers were closed and labeled.

SCENE BEING PHOTOGRAPHED: 90 day hazardous waste storage building

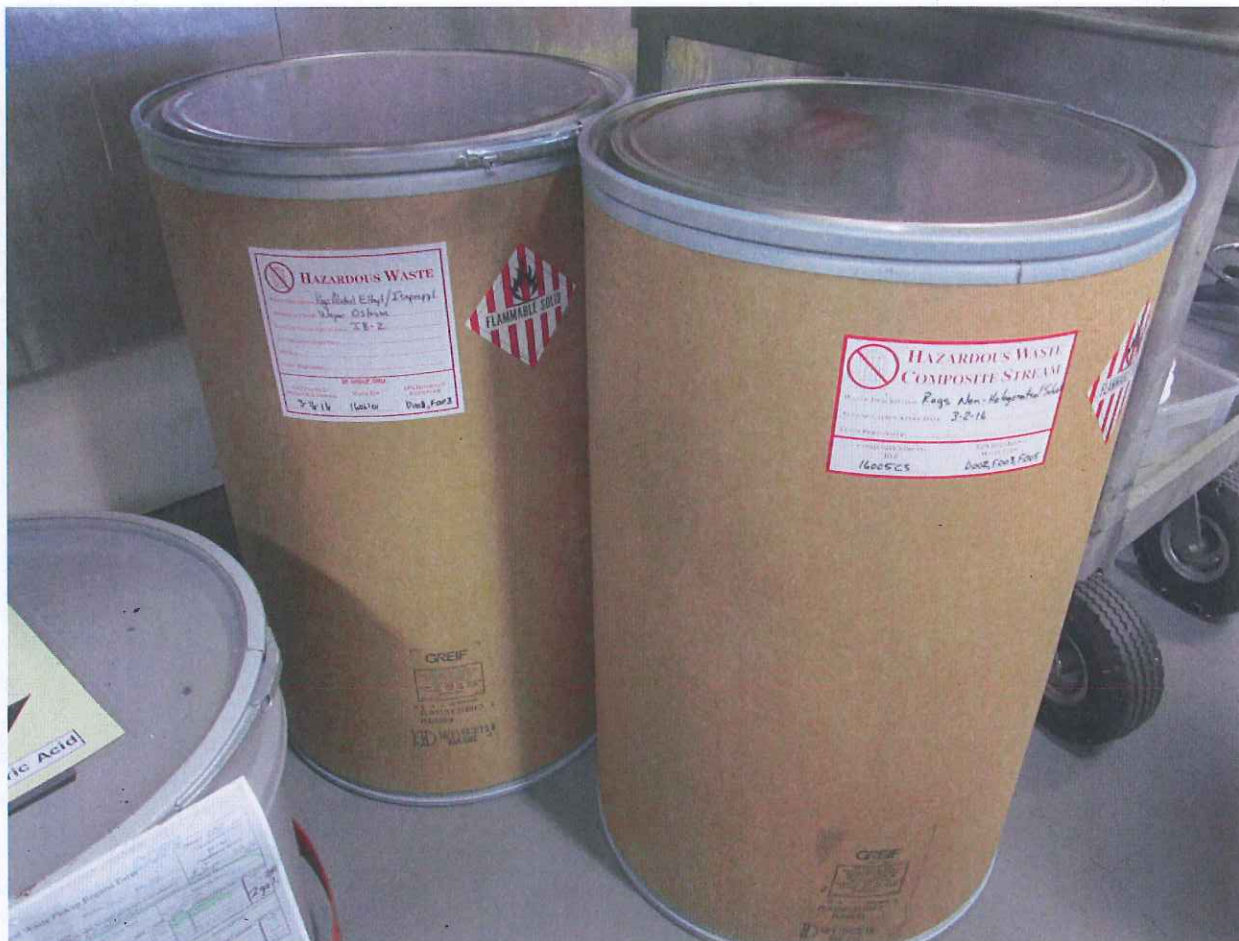
PHOTOGRAPH: 15

- There was one closed/labeled 55-gallon container of non-halogenated solvent waste rags being stored with the waste codes of, "D002, F003 and F005" (Photograph 15).

- There was one closed/labeled 55-gallon container of alcohol ethyl isopropyl waste rags being stored with the waste codes of, "D002 and F003" (Photograph 15).

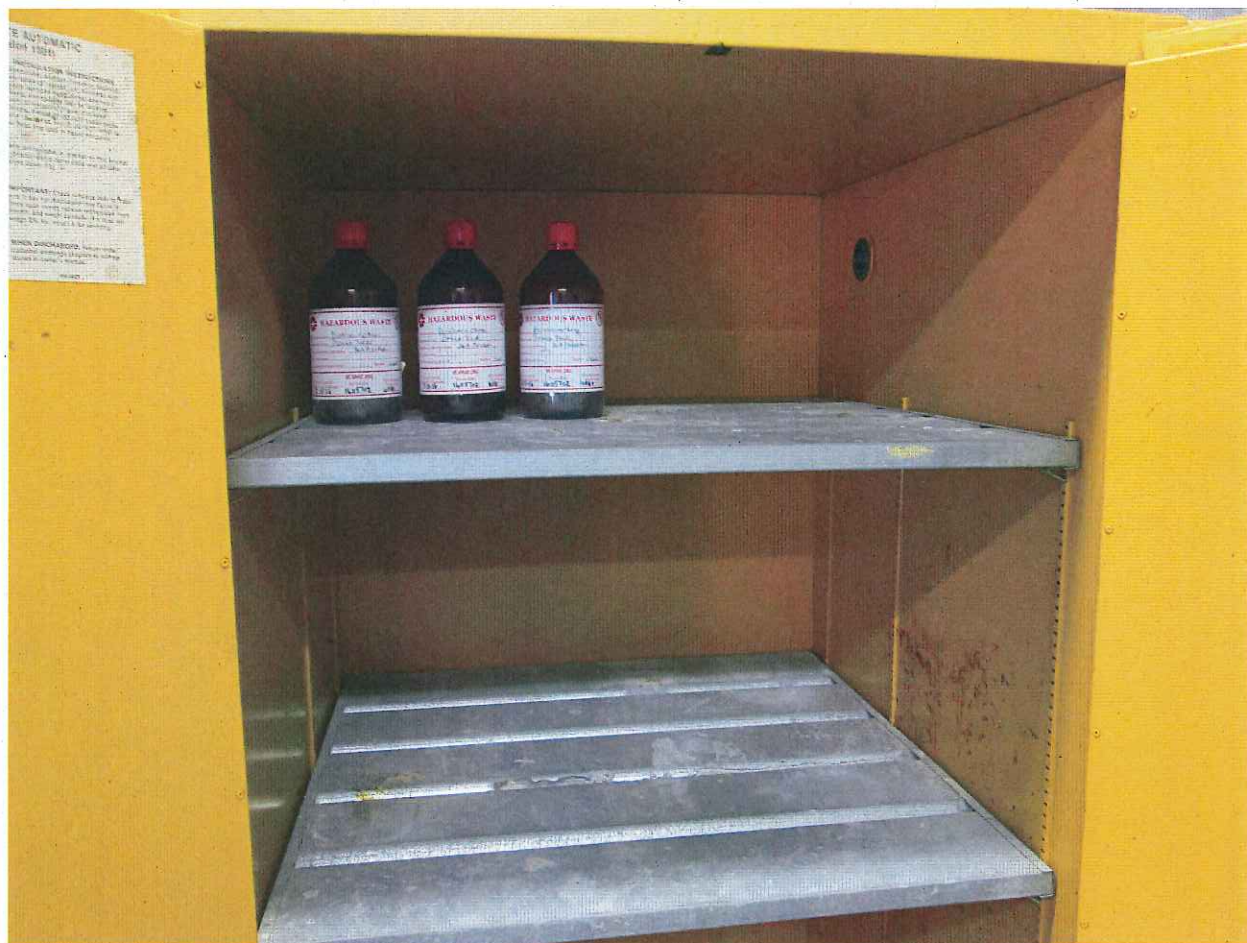
PHOTOGRAPH: 18

- There were three closed/labeled bottles of dichloromethane waste being stored in cabinet 10 (Photograph 18).
- There were closed/labeled small containers of hazardous waste with the waste code of D002 being stored in cabinet 12 (Photograph 19).

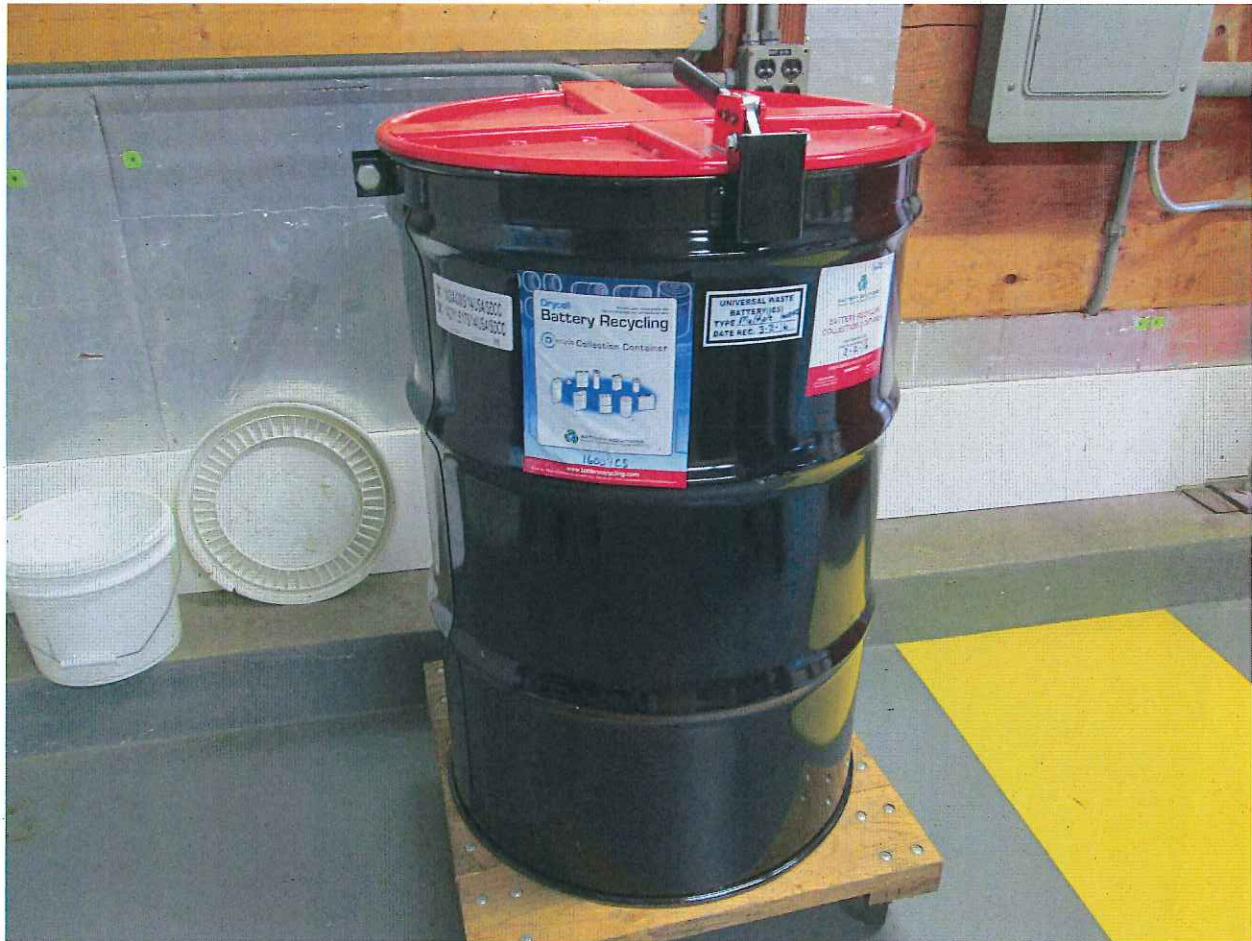
PHOTOGRAPH: 20

- There was also one 55-gallon container of batteries generated from computers laptops, etc. (Photograph 20).

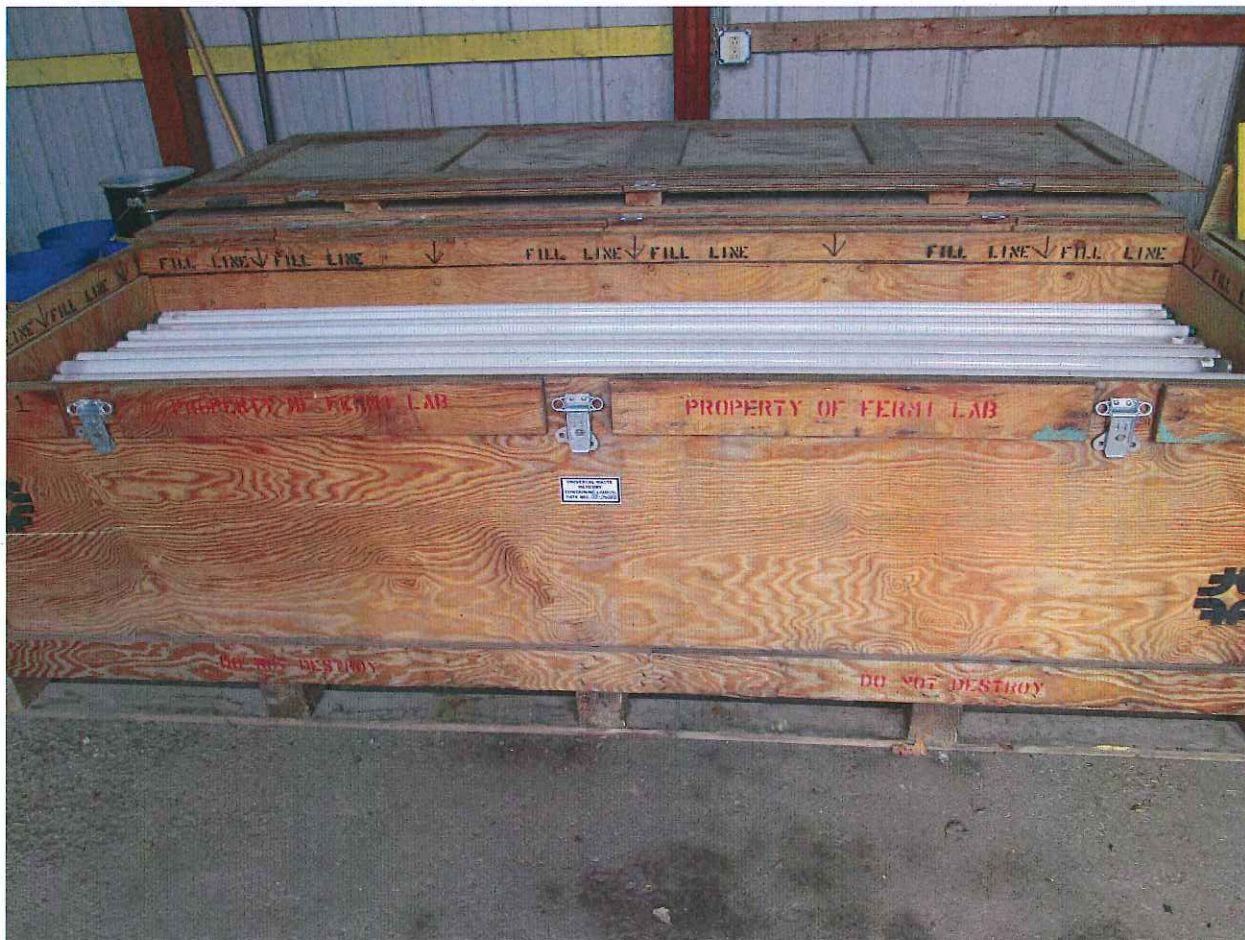
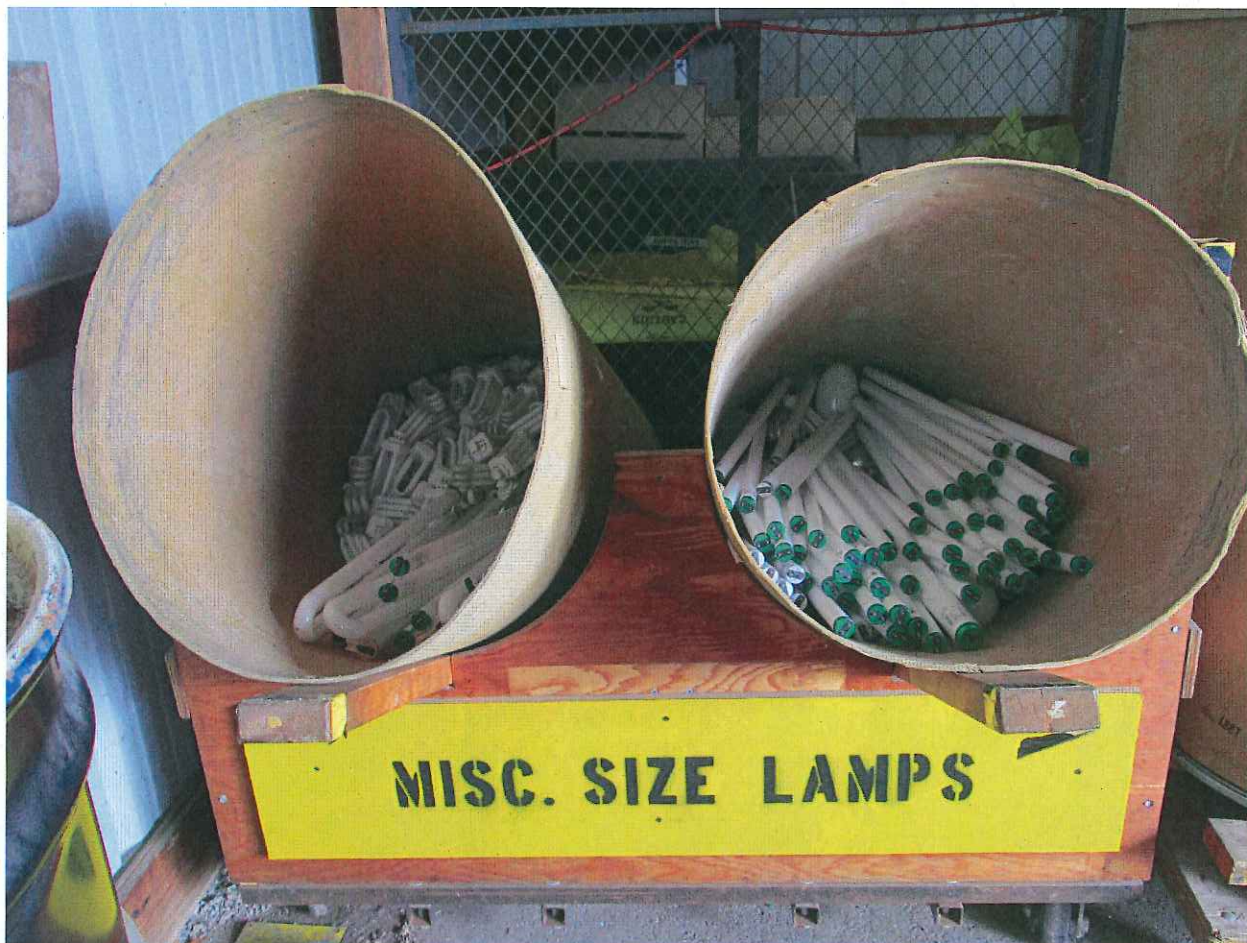
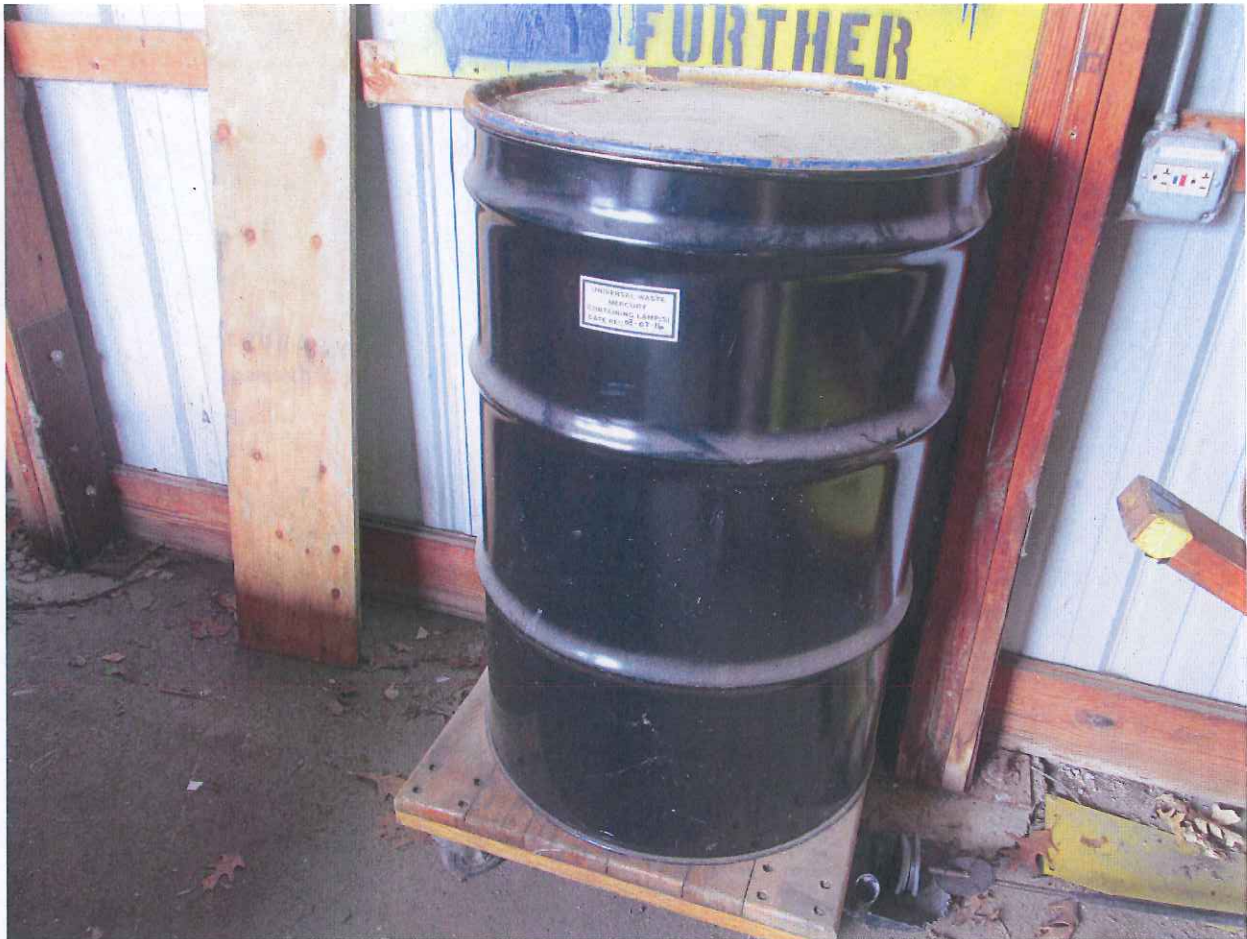
PHOTOGRAPH: 22

At the time of the inspection, Fermilab was storing waste lamps in four open containers.

We then proceeded to Site 38, the designated storage area for universal waste lamps. I observed four open containers and one closed 55-gallon container of waste lamps (Photographs 22 through 25). The four open containers were closed at the time of the inspection (Photographs 26 and 27). All containers were labeled universal waste lamps.

During the inspection, as observed by EPA, you took certain actions to establish compliance with violation number 2.

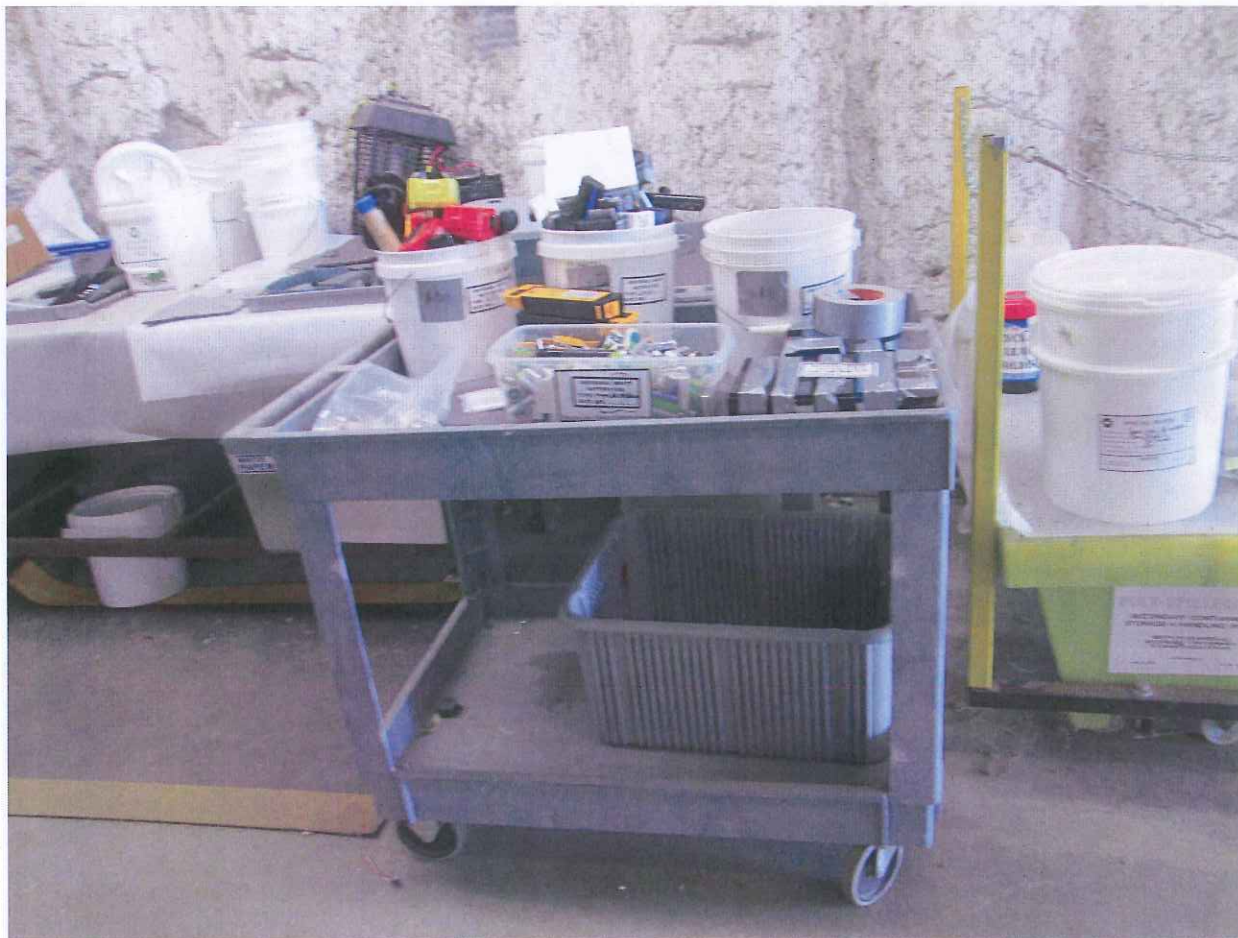
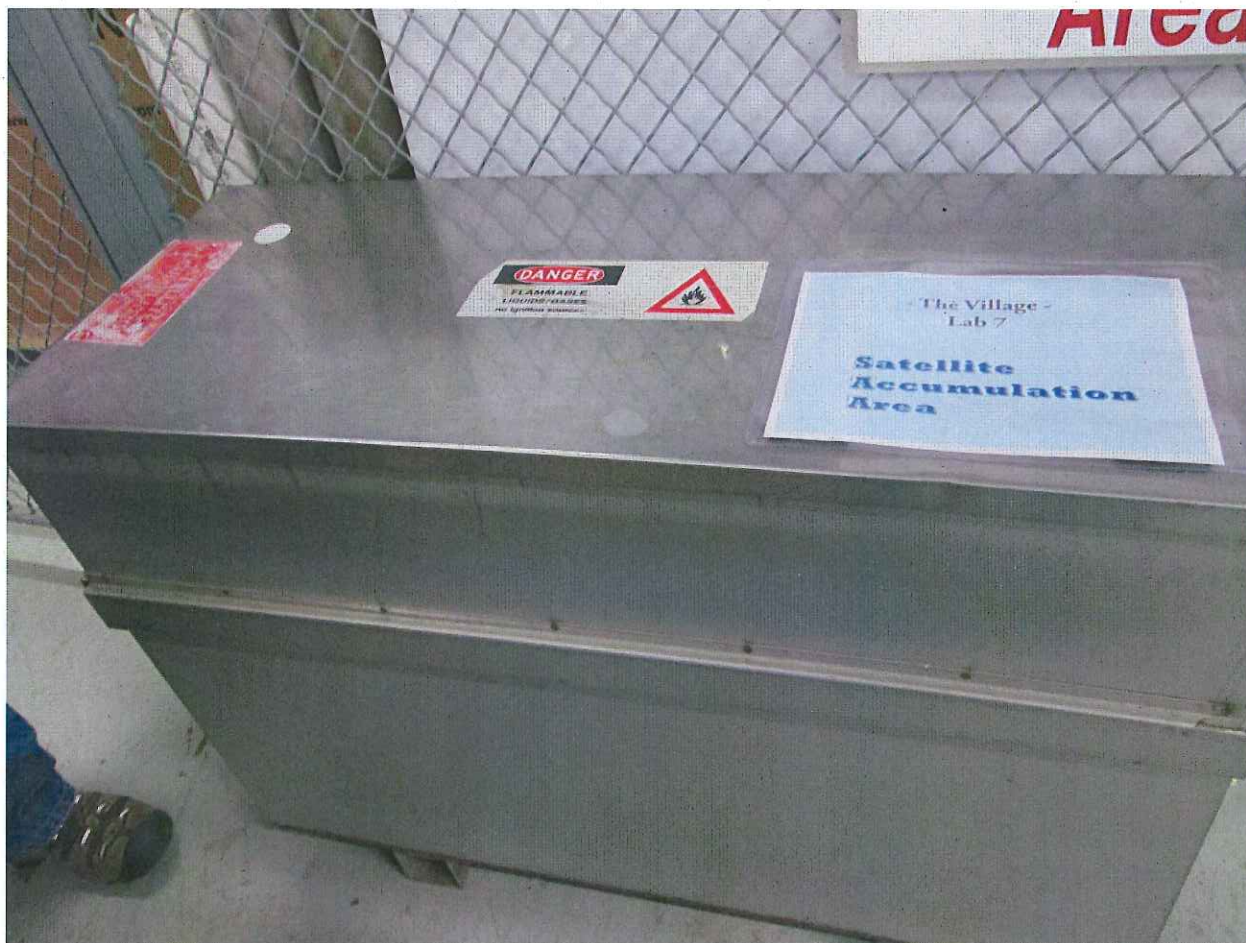
PHOTOGRAPH: 28

Next, we proceeded to the battery sorting area (ME-7 Worm) and then to the Thin Film Village Lab where I observed a satellite accumulation container of eight 1-liter bottles of ethanol waste and a bag of waste rags (Photographs 28 through 31).
